INVESTIGATION OF REJUVENATION OF FATIGUE  
DAMAGE IN Ti-6Al-4V

BATTELLE- COLUMBUS LABORATORIES  
505 King Avenue  
Columbus, Ohio 43201

JULY 1977

TECHNICAL REPORT AFML-TR-77-107  
INTERIM REPORT FOR PERIOD

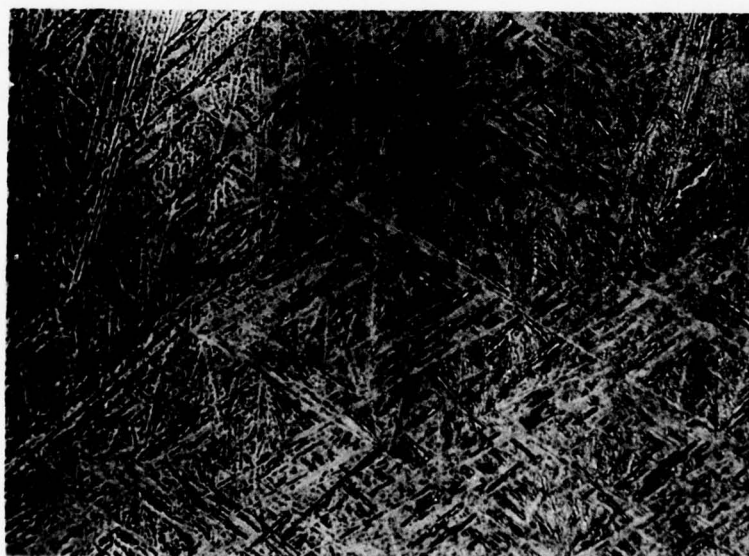
FIGURE 1. MICROSTRUCTURE OF Ti-6Al-4V IN THE  $\beta$ STOA CONDITION USED FOR THE FATIGUE EXPERIMENTS

\* The microstructure of the specimens were the same for both lots as seen by optical metallography (Figure 1).

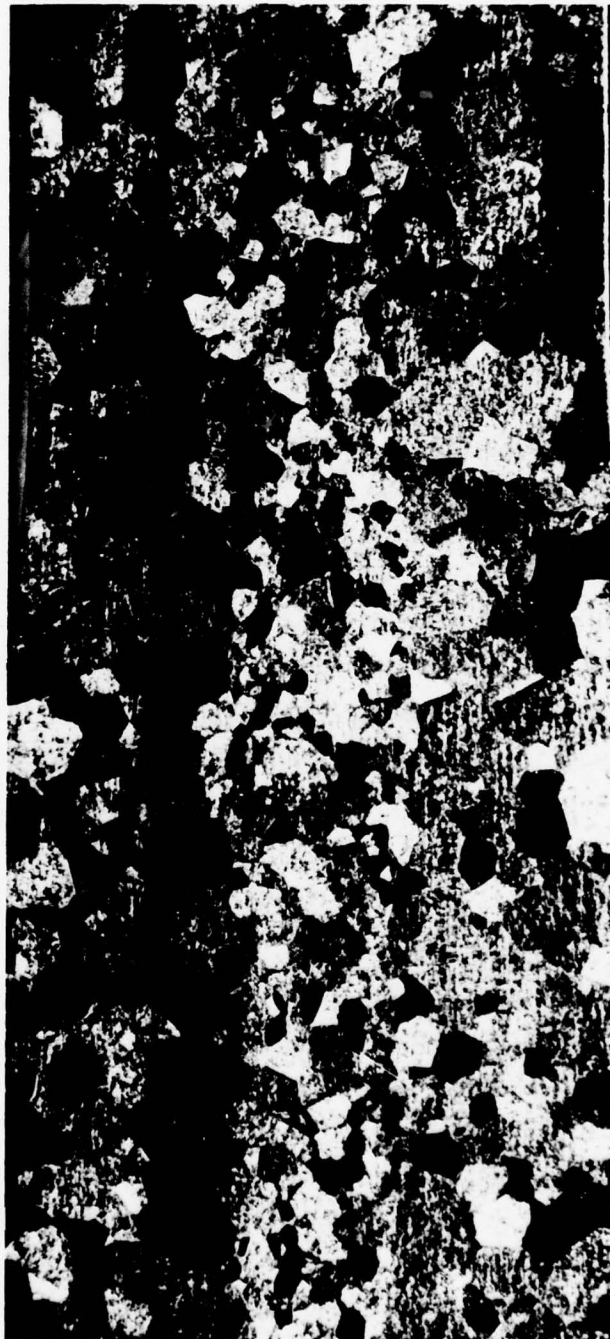
FIGURE 2. THE DUPLEX GRAIN STRUCTURE IN THE FATIGUE SPECIMENS, MADE UP OF A FINE-GRAINED CORE IN A COARSE-GRAINED SHEATH

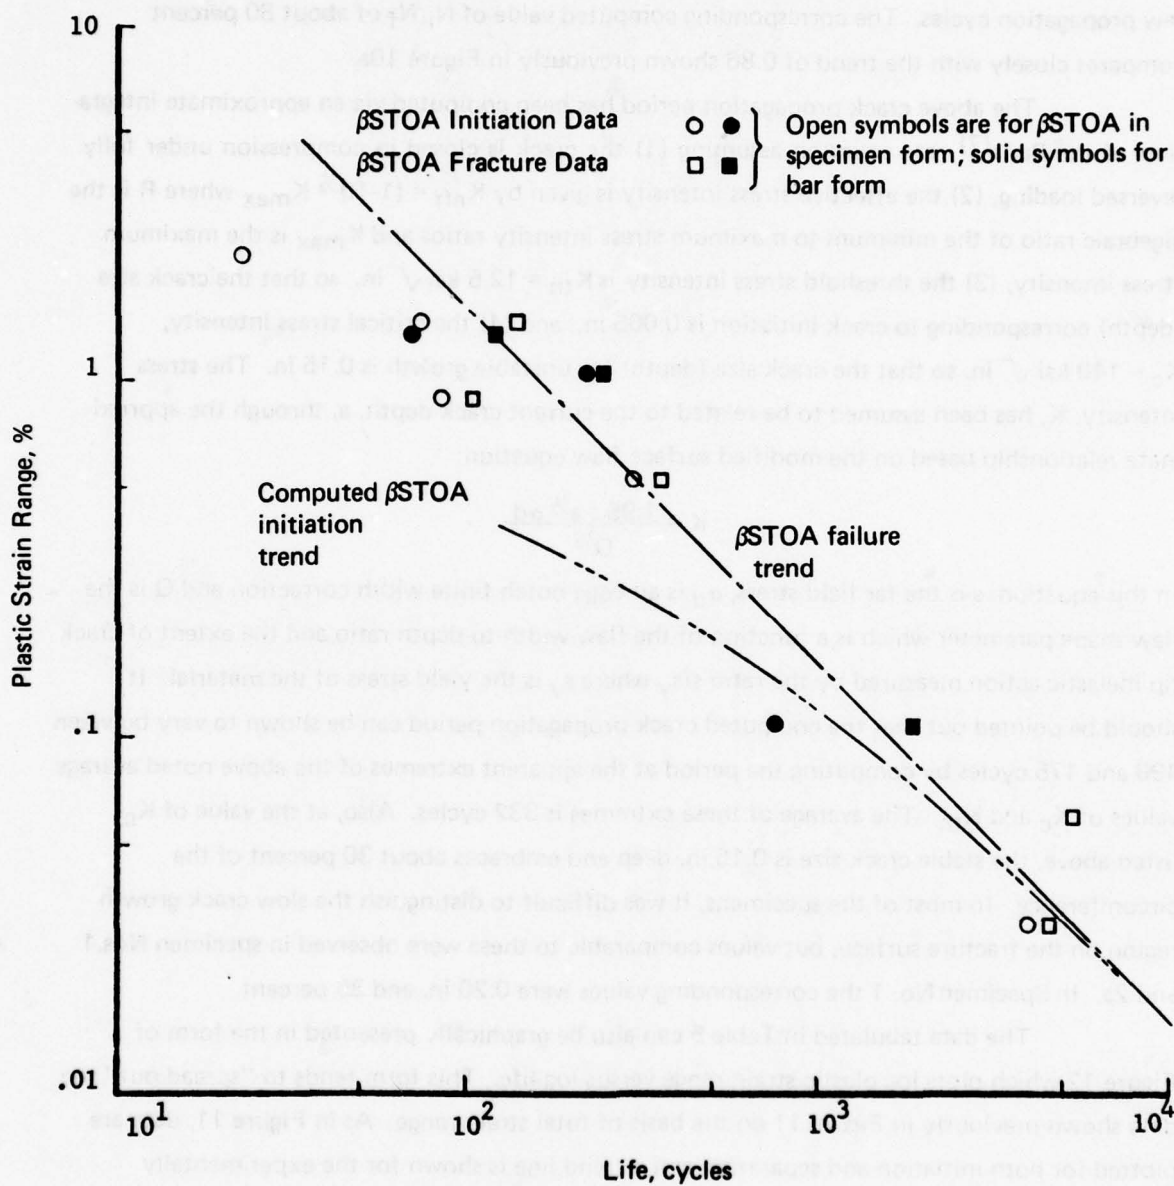
**FIGURE 12. BASELINE PROPERTY DATA PRESENTED ON THE BASIS OF PLASTIC STRAIN RANGE**

The data tabulated in Table 5 can also be graphically presented in the form of Figure 12 which plots log plastic strain range versus log life. This form tends to "spread out" the data shown previously in Figure 11 on the basis of total strain range. As in Figure 11, data are plotted for both initiation and separation and a trend line is shown for the experimentally measured separation life. This plastic strain-life to separation line has been established giving consideration to three major factors: (1) the distribution of the fatigue failure data, (2) the value of the true fracture strain range (0.228 of the true fracture strain measured from a tensile test) through which the curve should pass, and (3) the characteristic slope of such Coffin-Manson plots. The chosen trend curve drawn in Figure 12 has a slope of about -0.5, almost passes through the

true fracture strain\*, and provides a reasonable fit through the failure data without encompassing any of the initiation data at lives to crack initiation greater than 100 cycles, except for one long life point. Also as in Figure 11, a trend curve corresponding to crack initiation based on the measured failure data and a constant crack propagation period of 332 cycles (consistent with the trend in the value of  $N_i/N_f$  of Figure 10) is shown in this figure. Note that this value of 332 cycles corresponds closely with the average value of the propagation period for baseline data of 371 cycles. Note also that this trend seems to provide a reasonable fit to the initiation data.

\* The point for true fracture strain is not included in Figure 12, but lies off to the left.

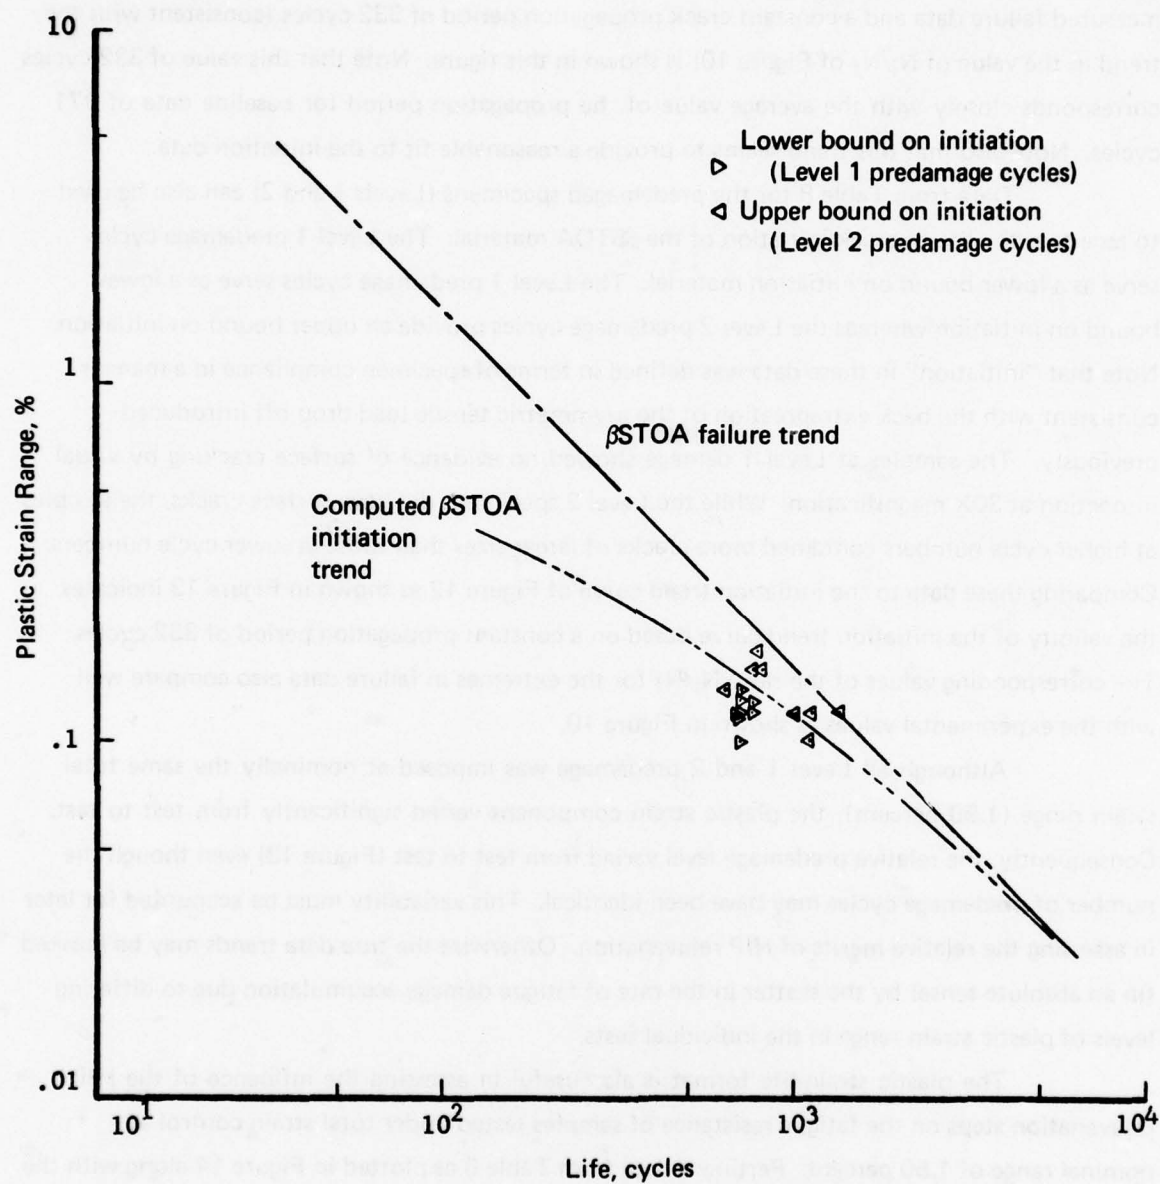
FIGURE 13. COMPARISON OF PREDAMAGED SPECIMEN PROPERTIES TO THE INITIATION TREND CURVE

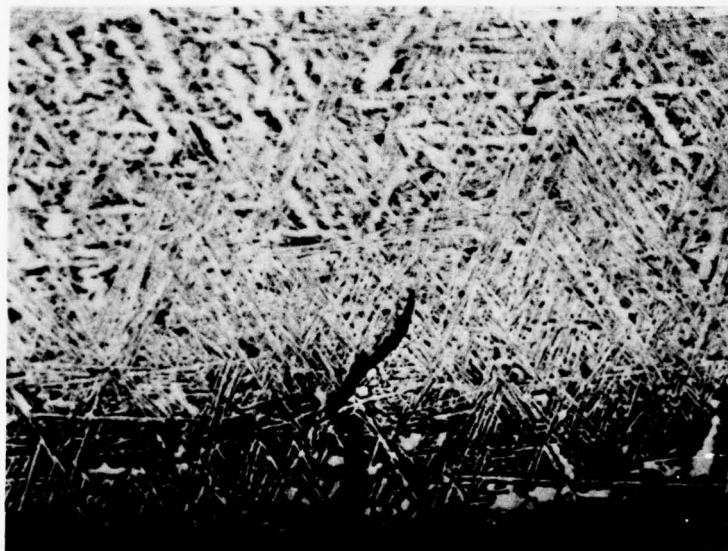
- a. Surface configuration of crack. Large crack adjacent to area shown in Figure 10b.

- b. Profile of crack seen on longitudinal section. Vertical section through the crack shown in a above. The tip of the arrow lies on the bonded crack, which is an extension of the slanted lower portion of the open crack.

FIGURE 24. CONFIGURATION OF PARTIALLY BONDED CRACK LOCATED IN THE REGION SHOWN IN FIGURE 23

The surface layer is nickel not completely removed after HIP.

The light surface layer in Figures 24 to 26 is a thin layer of the nickel plating which was not completely removed after HIP. The dark region below the nickel plate is a high nickel

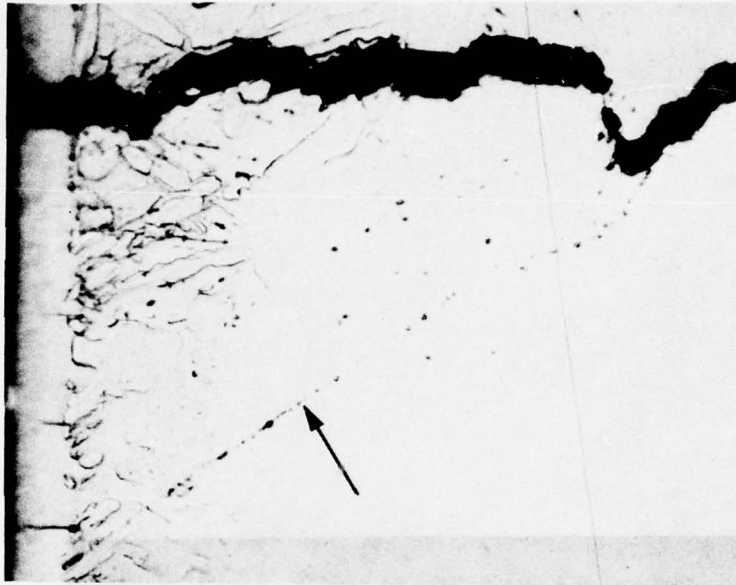
FIGURE 25. SHOWS DETAIL OF PARTIALLY BONDED CRACK INDICATED BY THE ROW OF POROSITY REMAINING AFTER INCOMPLETE BONDING

b. Etched surface partially polished

1000 X

The layer is nickel not completely removed after HIP.

The original (partially bonded) crack has the appearance of the Stage I cracks shown earlier (Figures 20 and 22b); following interphase boundaries in from the surface. The new crack, initiated during final fatigue testing to failure, may have initiated in this location either because of the large concentration of previous fatigue damage here or the presence of the open crack segment located below the surface. After propagating into the specimen a short distance, it intersected the original partially bonded crack. However, it is not clear whether the original crack had partly bonded along its entire original length and subsequently reopened after the new crack impinged on it, or whether only the upper part had bonded as suggested by Figure 26.

The nickel layer (Figures 25 and 26) contains numerous cracks normal to the surface extending completely through the nickel layer. These are potential crack initiation sites, and the crack in Figure 26 presumably started at one of these. Also the nickel diffusion zone probably has quite different fatigue properties compared to Ti-6Al-4V. Being at the surface, this zone could strongly influence the final fatigue properties. In one sense at least, crack initiation is different in this layer than in Ti-6Al-4V. The crack appears to enter Stage II very near the surface and propagates through the particles of the light phase (probably  $\alpha$ ) rather than along interphase boundaries as observed in Ti-6Al-4V.

These improvements were obtained using surface coatings, which to work best should be mechanically and chemically compatible with the Ti-6Al-4V specimens. Any degradation of properties through effects of the coatings such as lowering fatigue crack initiation life or non-adherence detracts from associated improvements in life. An example is the cracks in the residual nickel coating seen in Figures 25 and 26, one of which propagated into the nickel diffusion zone in the surface of the fatigue specimen.

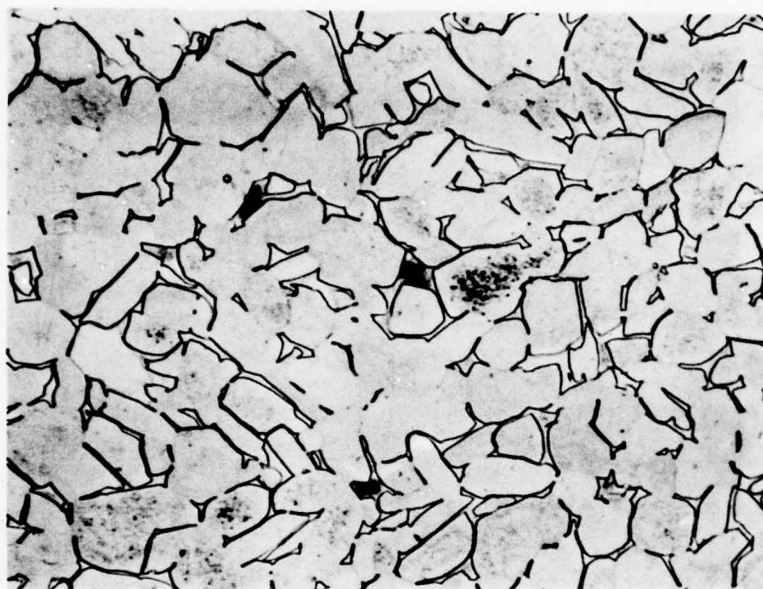
FIGURE 29. MICROSTRUCTURE OF Ti-6Al-4V BAR AFTER 954 C (1700 F), 1 HOUR, LONGITUDINAL SECTION WITH LONGITUDINAL AXIS HORIZONTAL

1000 X

a.

250 X

b.

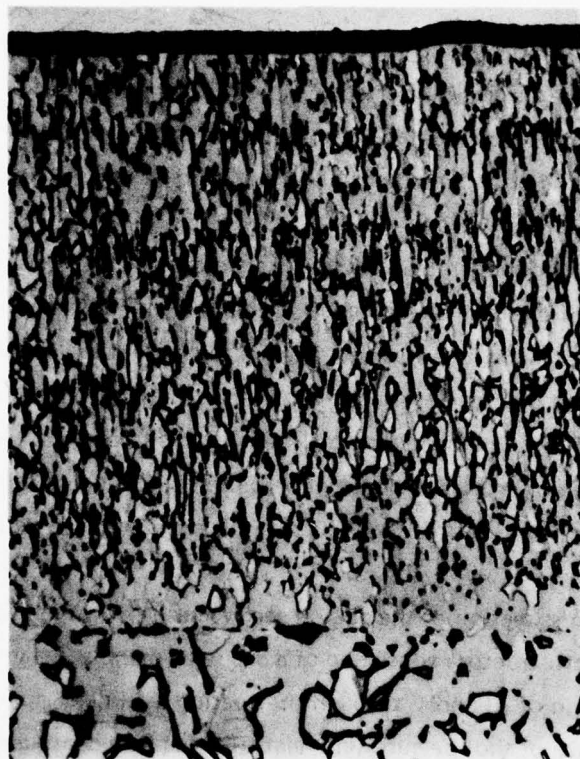
FIGURE 33. Ti-Al-V COATING MICROSTRUCTURE IN THE AS-DEPOSITED CONDITION

1000 X

A typical cross section of the coated specimens is shown in Figure 33. The coatings would have a duplex microstructure consisting of  $\alpha + \beta$  with the relative amounts of each phase depending on the variation of Al and V through the coating thickness.

The influence of shot peening and heat treatment on coating microstructure, hardness, and bonding to the substrate was investigated. Coated specimens having peened and ground substrate surfaces were heat treated at 704 C (1299 F) for 3 hours (mill anneal) and examined (Figure 34). The overall effect of this treatment was to significantly increase the coating grain size and initiate diffusion bonding of the coating to the substrate as shown by comparison of Figure 34 with Figure 33.

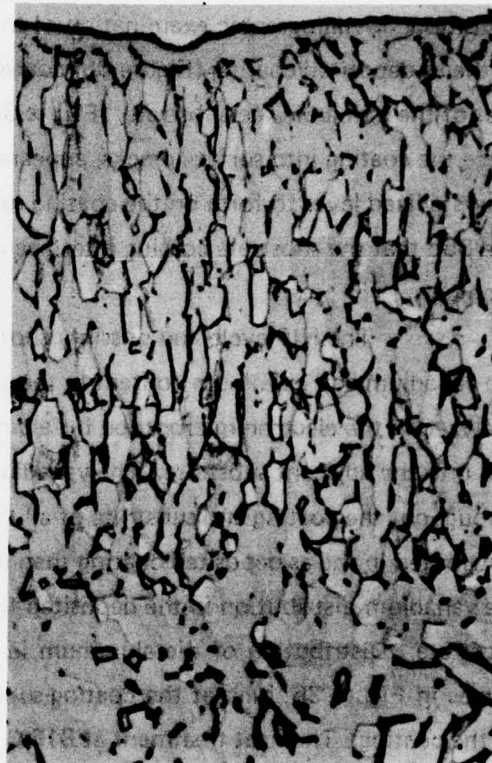
FIGURE 35. Ti-Al-V COATING MICROSTRUCTURE AFTER 815 C (1500 F), 3 HOUR, HIP SIMULATION HEAT TREATMENT

a. As-deposited & heat treated 1000 X

b. Peened prior to heat treat 1000 X

The effects of peening and HIP on coating morphology were investigated using a single coated disk cut into three pieces. Two of these segments, one of which was shot peened, were vacuum heat treated at 815 C (1500 F) for 3 hours with slow cooling to simulate the temperature profile of a possible HIP treatment. The third segment was left in the as-coated condition. Metallographic examination of these segments showed that the fine columnar structure of the as-deposited coating (Figure 33) coarsened to an elongated  $\alpha$ - $\beta$  microstructure similar to that of the mill-annealed substrate, (Figure 35). Peening prior to HIP, a possible treatment to force the coating into surface cracks, appears to cause a thin (approximately one grain) recrystallized layer to form on the coating surface. Also, there is some indication in Figure 35a and 35b that the substrate coating interface is more diffuse and therefore better bonded after shot peening.
